USACERL Technical Report 96/15  
December 1995

# Historic Preservation Plan for St. Johns River Lighthouse, Naval Station Mayport, Florida

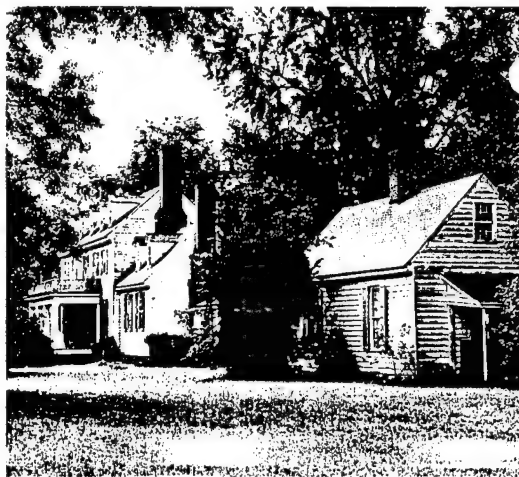
1. Eighteenth century and later vernacular architecture depended on the siting of the building, deciduous trees, cross ventilation, and the placement of windows and chimneys to maximize winter heating and natural summer cooling. Regional details, as seen in this Virginia house, include external chimneys and a separate summer kitchen to reduce fire risk and isolate heat in the summer. Photo: NPS Files.

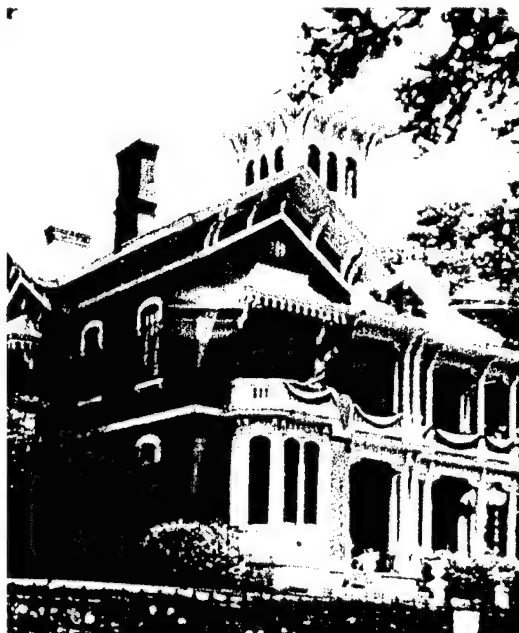
2. Nineteenth century buildings continued to use architectural features such as porches, cupolas, and awnings to make the buildings more comfortable in summer, but heating was greatly improved by hot water or steam radiators. Photo: NPS Files

**Nineteenth Century.** The industrial revolution provided the technological means for *controlling the environment* for the first time (see figure 2). The dual developments of steam energy from coal and industrial mass production made possible early central heating systems with distribution of heated air or steam using metal ducts or pipes. Improvements were made to early wrought iron boilers and by late century, steam and low pressure hot water radiator systems were in common use, both in offices and residences. Some large institutional buildings heated air in furnaces and distributed it throughout the building in brick flues with a network of metal pipes delivering heated air to individual rooms. Residential designs of the period often used gravity hot air systems utilizing decorative floor and ceiling grilles.

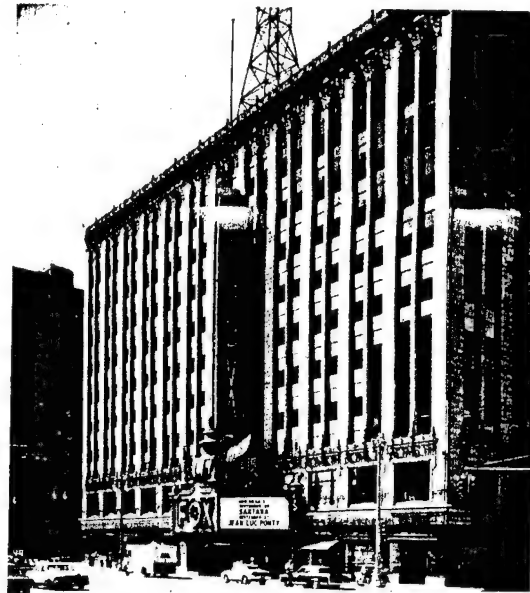
3. The circa 1928 Fox Theater in Detroit, designed by C. Howard Crane, was one of the earliest twentieth century buildings to provide air conditioning to its patrons. The early water-cooled system was recently restored. Commercial and highrise buildings of the twentieth century were able, mostly through electrical power, to provide sophisticated systems that integrated many building services. Photo: William Kessler and Associates, Architects.

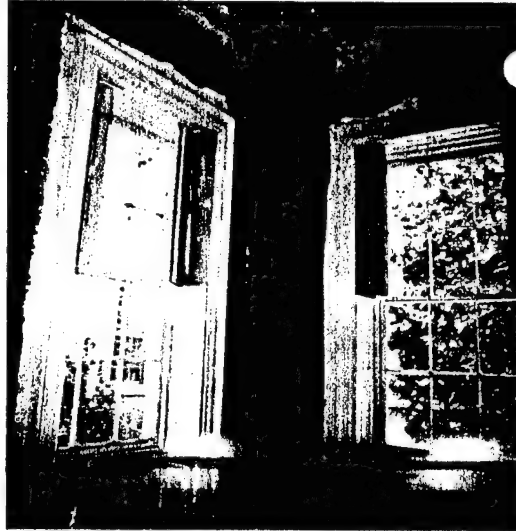
5. The installation of vapor retarders in walls of historic buildings in an effort to contain interior moisture can cause serious damage to historic finishes as shown here. In this example, all the wall plaster and lath have been stripped in preparation for a vapor barrier prior to replastering. Controlling interior temperature and relative humidity can be more effective than adding insulation and vapor barriers to historic perimeter walls. Photo: Ernest A. Conrad, P.E.

To avoid these types of damage to a historic building, it is important to understand how building components work together as a system. Methods for controlling interior temperature and humidity and improving ventilation must be considered in any new or upgraded HVAC or climate control system. While certain energy retrofit measures will have a positive effect on the overall building, installing effective vapor barriers in historic walls is difficult and often results in destruction of significant historic materials (see figure 5).

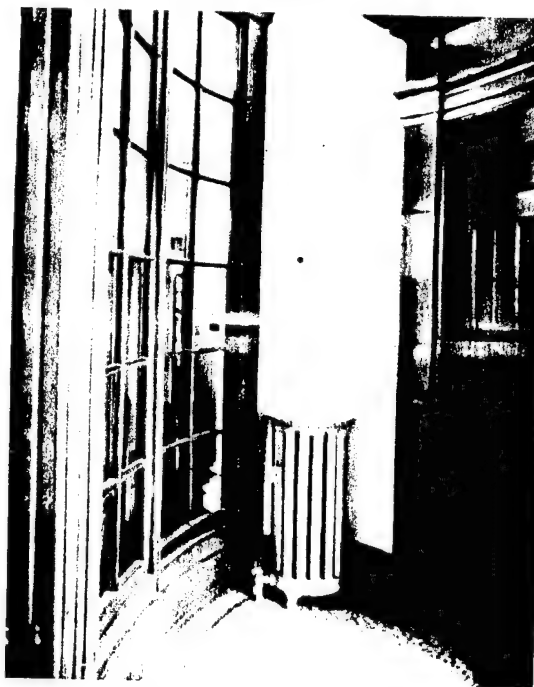
6. A condition assessment during the planning stage would identify this round radiator in a small oval-shaped vestibule as a significant element of the historic heating system. In upgrading the mechanical system, the radiator should be retained. Photo: Michael C. Henry, P.E., AIA.

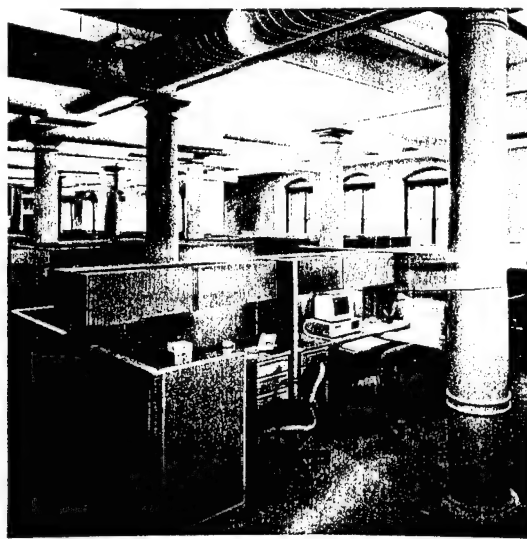
after

d. Auditors Buildings, Washington, D.C. This upper floor workspace had been modified over the years with dropped ceilings and partitions. In the recent restoration, the open plan workspace was restored, the false ceiling was removed, and the fireproof construction was exposed. A variable air volume (VAV) system using round double shell exposed ductwork is in keeping with the industrial character of the architectural space. Photo: Kenneth Wyner Photography, courtesy of Notter Finegold + Alexander Inc. Before view provided by Notter Finegold + Alexander/Mariani.

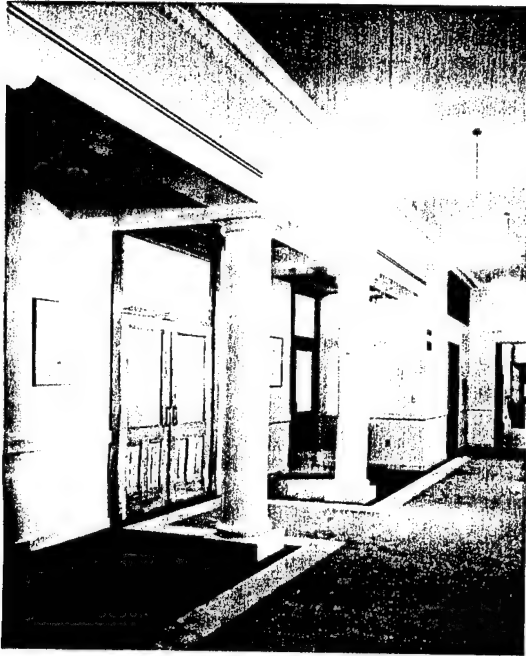
b. Central air conditioning was installed in the corridors of this circa 1900 school building by adding an air handler over the entrance from a vestibule. Custom-designed slot registers provide linear diffusers without detracting from the architecture of the space. Photo: Lautman Photography courtesy of Notter Finegold + Alexander Inc.

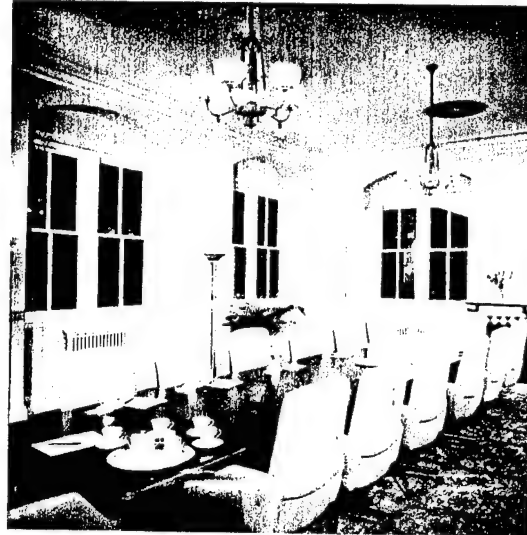
c. Conference room, Auditors Building, Washington, D.C. The historic steam radiators were retained for heating. The cast iron ceiling register was retained as a decorative element, but made inoperable to meet fire codes. Photo: Kenneth Wyner Photography courtesy of Notter Finegold + Alexander Inc.

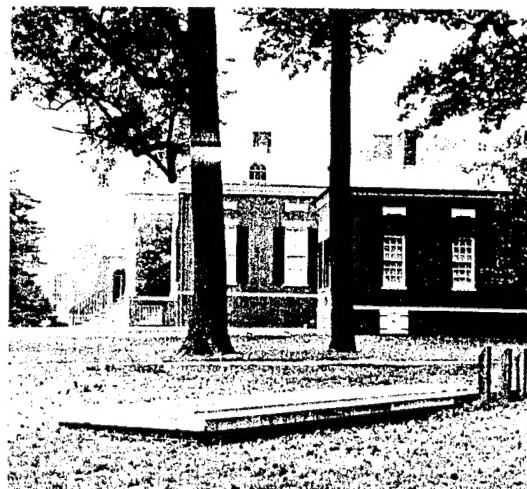
11. During the restoration of this 1806 National Historic Landmark (photo a), a new climate control system was installed. The architects removed all the earlier mechanical equipment from the house and installed new equipment in a 30' x 40' concrete vault located underground 150 feet from the house itself (photo b). Only conditioned air is blown into the house reusing much of the circa 1930s ductwork. Photos: Thomas C. Jester.
